Fact behind Building Collapse in Shanghai

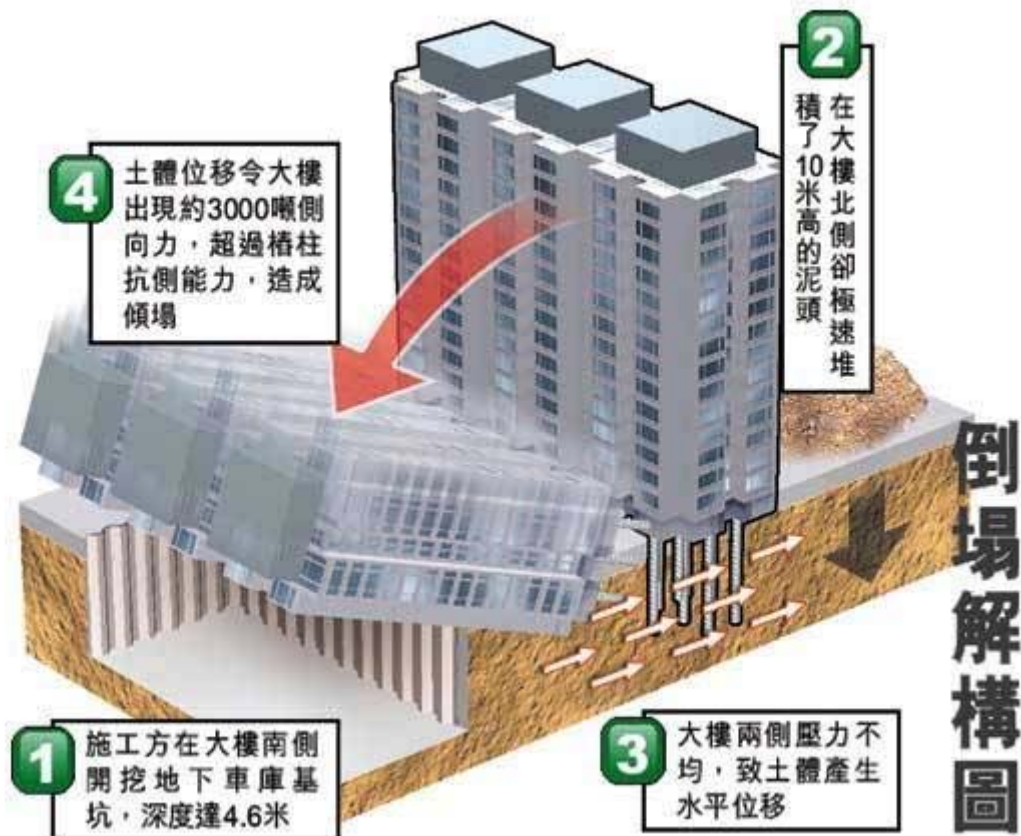
- (1) An underground garage was being dug on the south side, to a depth of 4.6 meters
- (2) The excavated dirt was being piled up on the north side, to a height of 10 meters
- (3) The building experienced uneven lateral pressure from south and north
- (4) This resulted in a lateral pressure of 3,000 tonnes, which was greater than why the pilings could tolerate. ? Thus the building toppled over in the southerly direction.

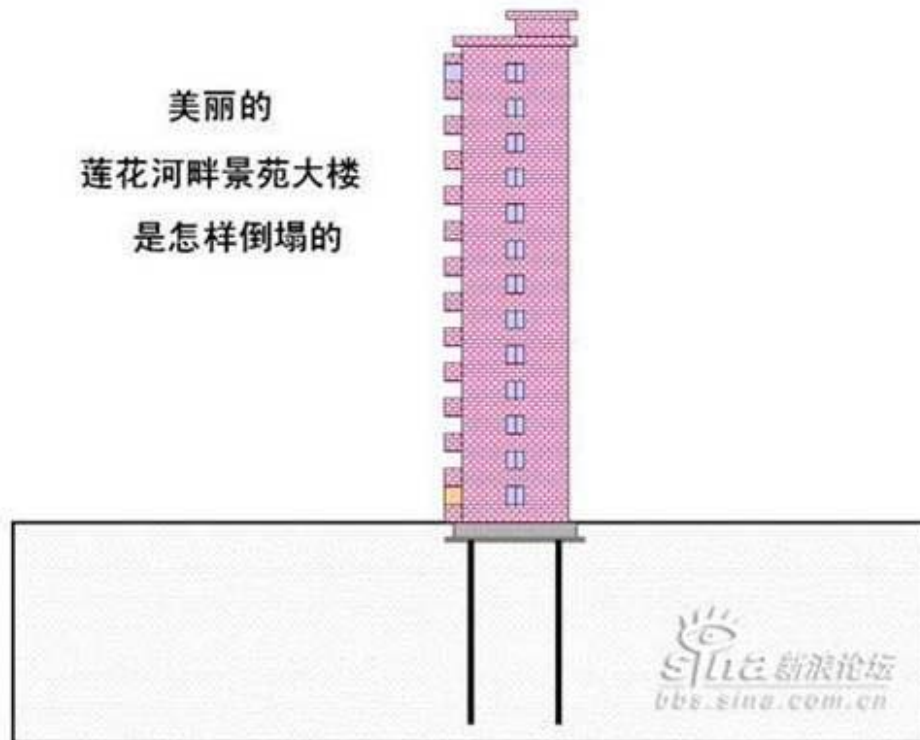
First, the apartment building was constructed

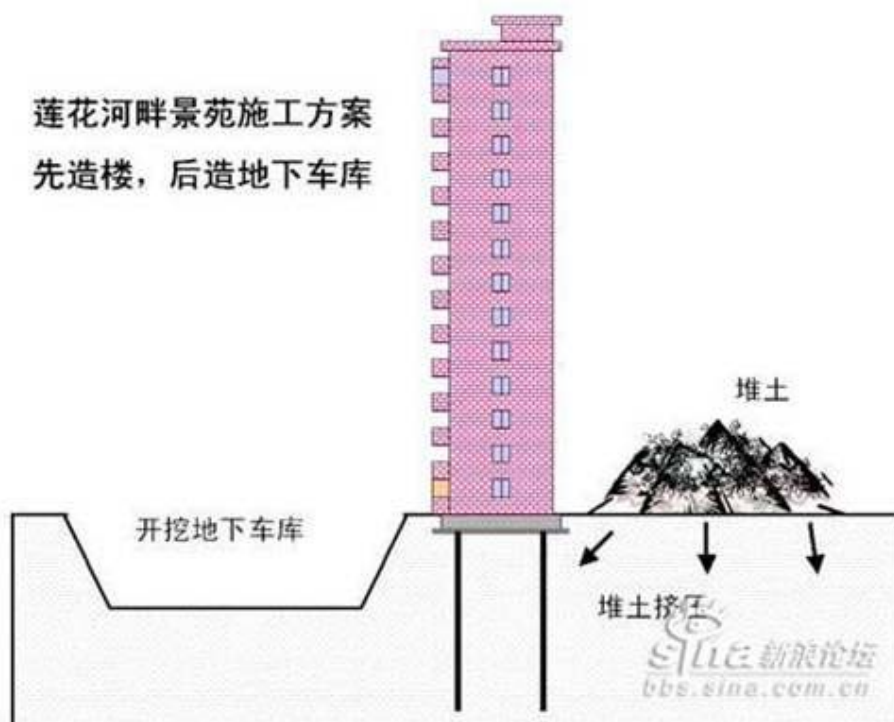
Then the plan called for an underground garage to be dug out.
The excavated soil was piled up on the other side of the
building.

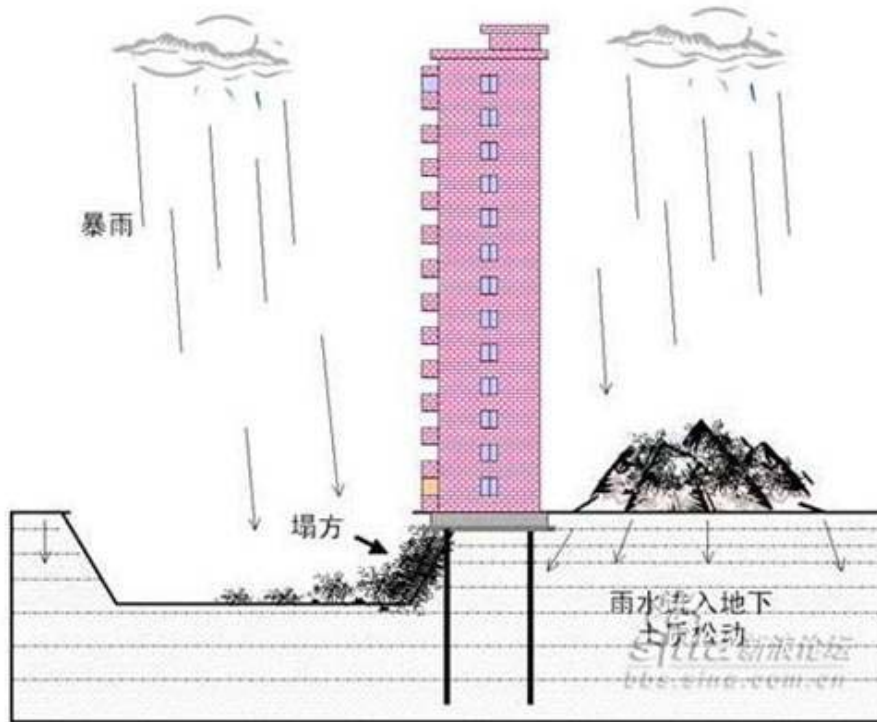
Heavy rains resulted in water seeping into the ground.

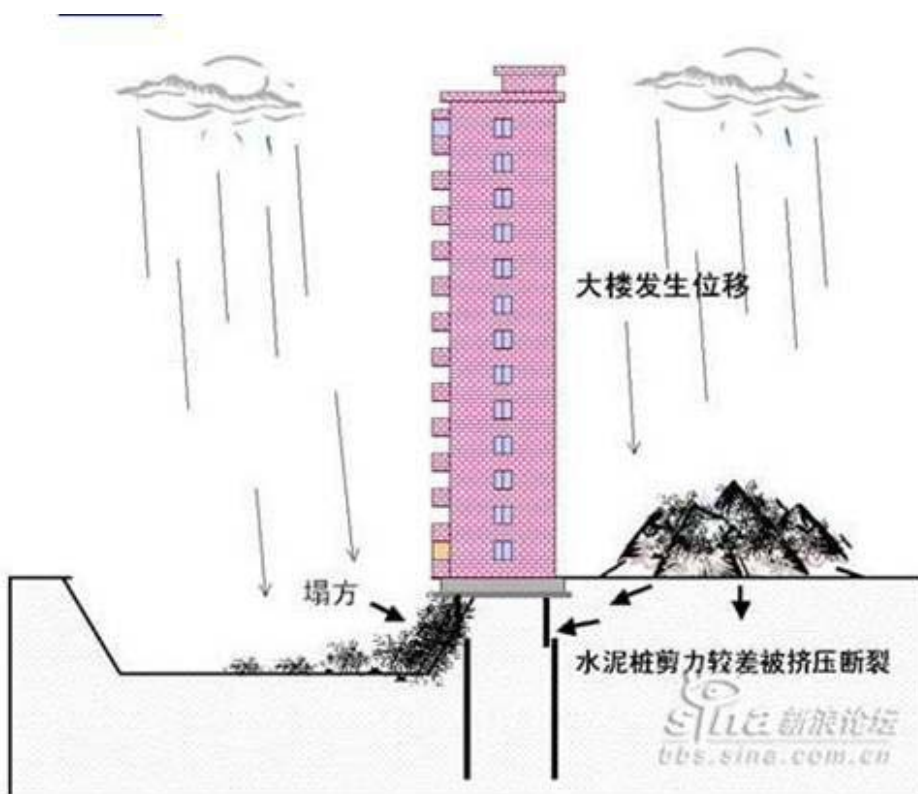
The building began to shift and the concrete pilings were snapped due to the uneven lateral pressures.

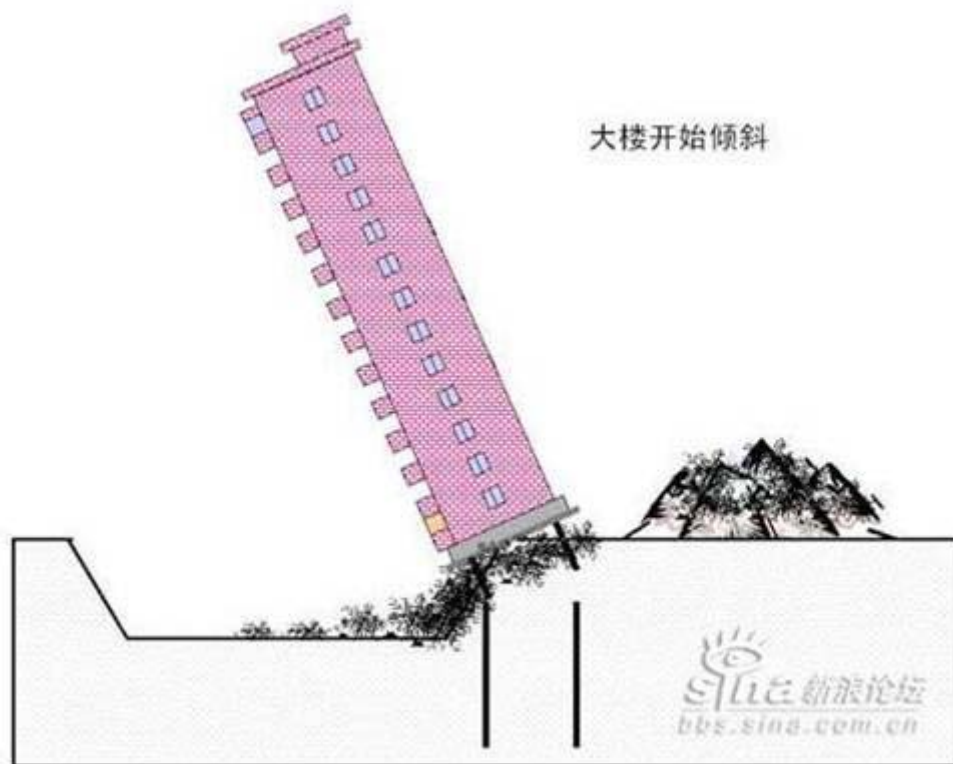
The building began to tilt.

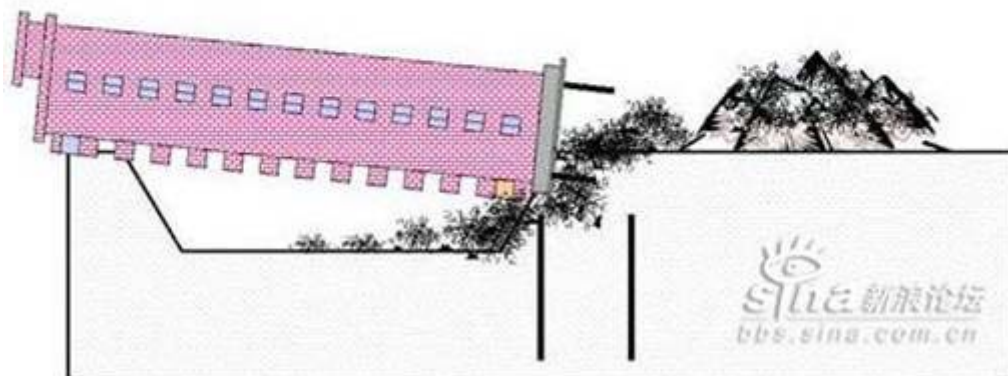
And thus came the eighth wonder of the world.
