## Fact behind Building Collapse in Shanghai

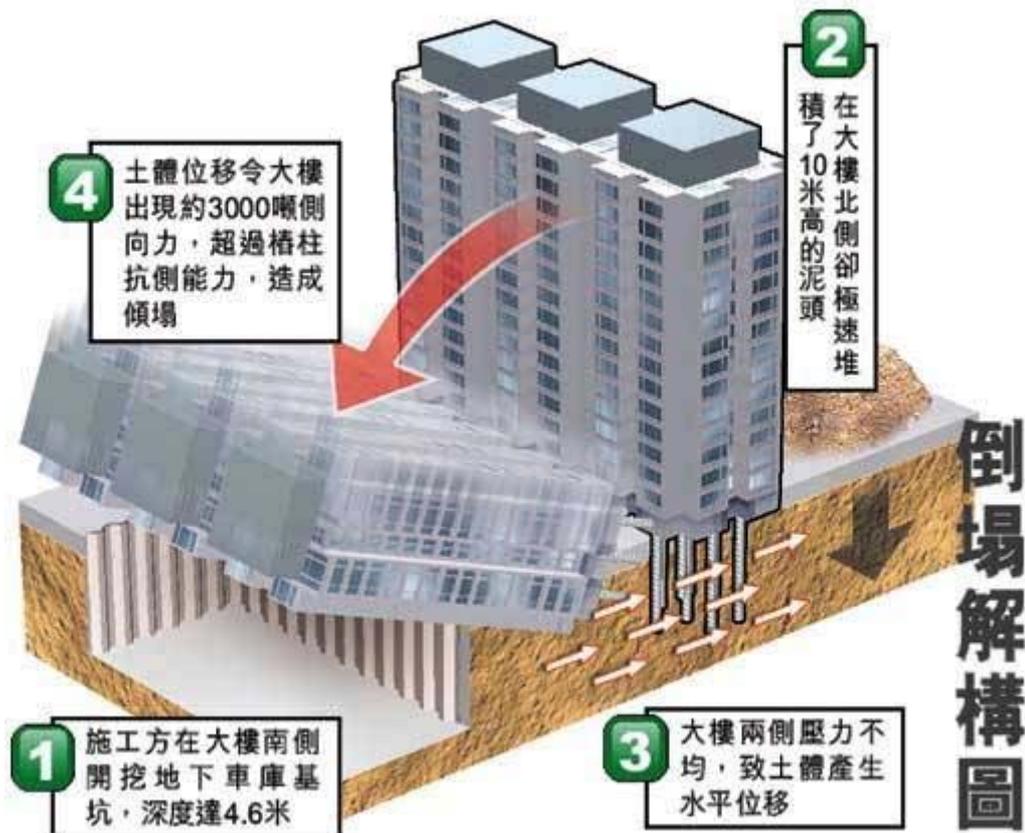
- (1) An underground garage was being dug on the south side, to a depth of 4.6meters
- (2) The excavated dirt was being piled up on the north side, to a height of 10meters
- (3) The building experienced uneven lateral pressure from south and north
- (4) This resulted in a lateral pressure of 3,000 tonnes, which was greater thanwhy the pilings could tolerate. ?Thus the building toppled over in the southerly direction.

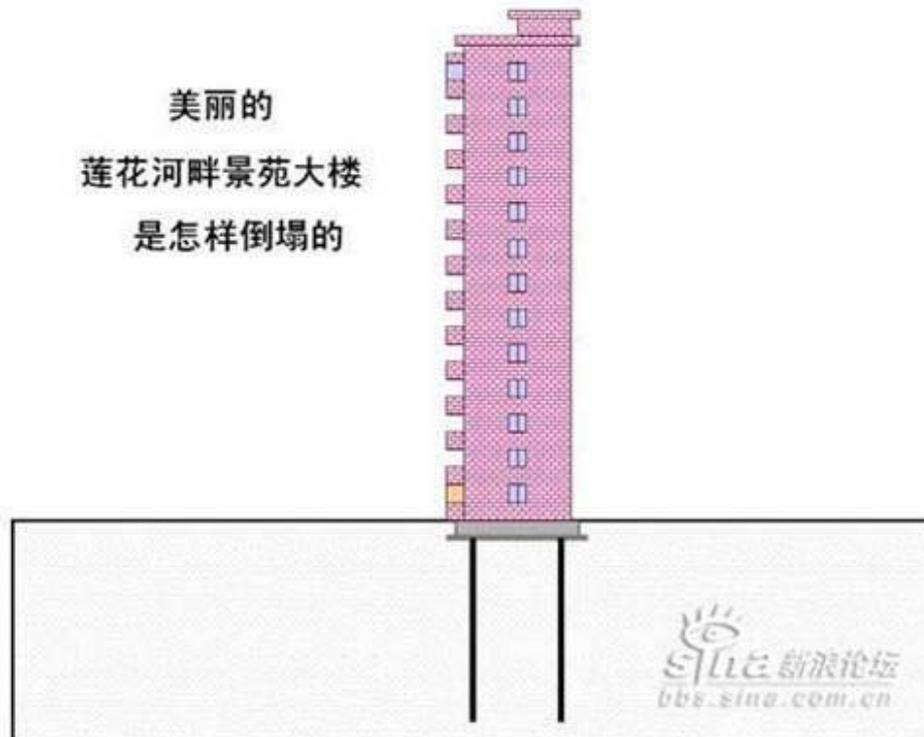
First, the apartment building was constructed

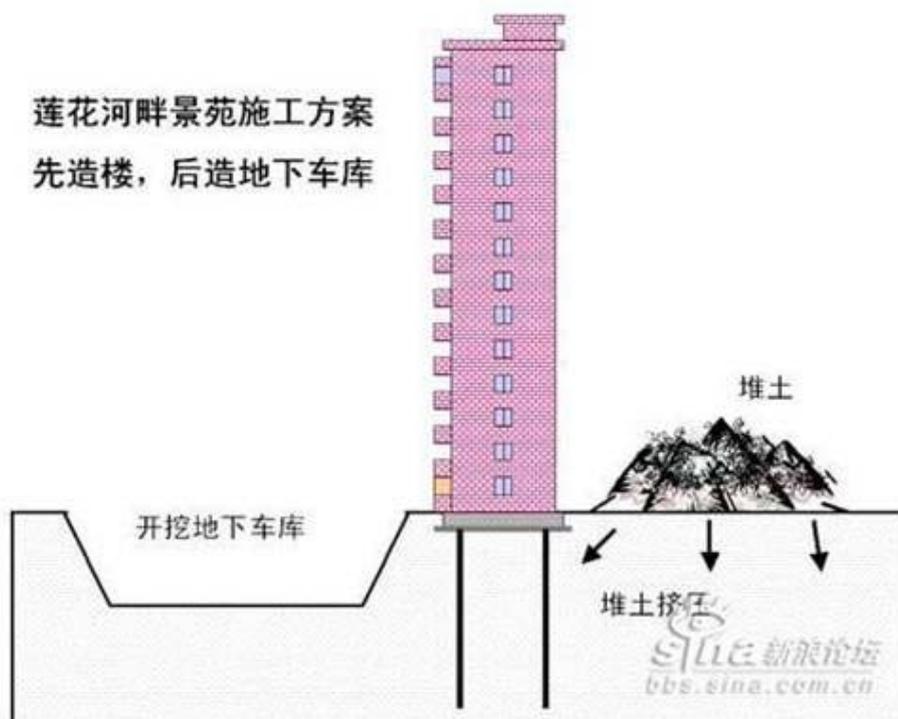
Then the plan called for an underground garage to be dug out.  
The excavated soil was piled up on the other side of the  
building.

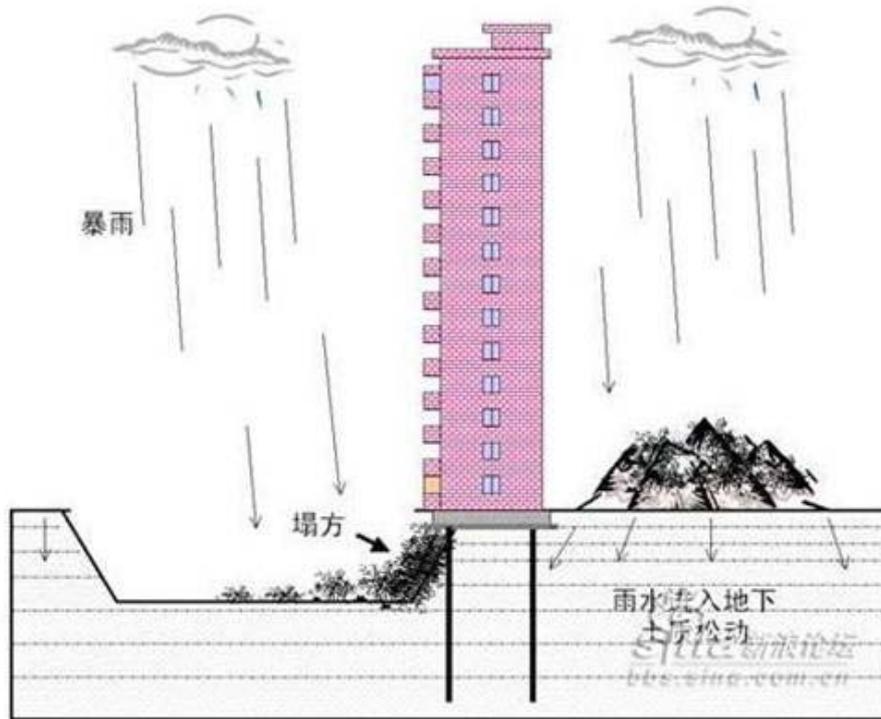
Heavy rains resulted in water seeping into the ground.

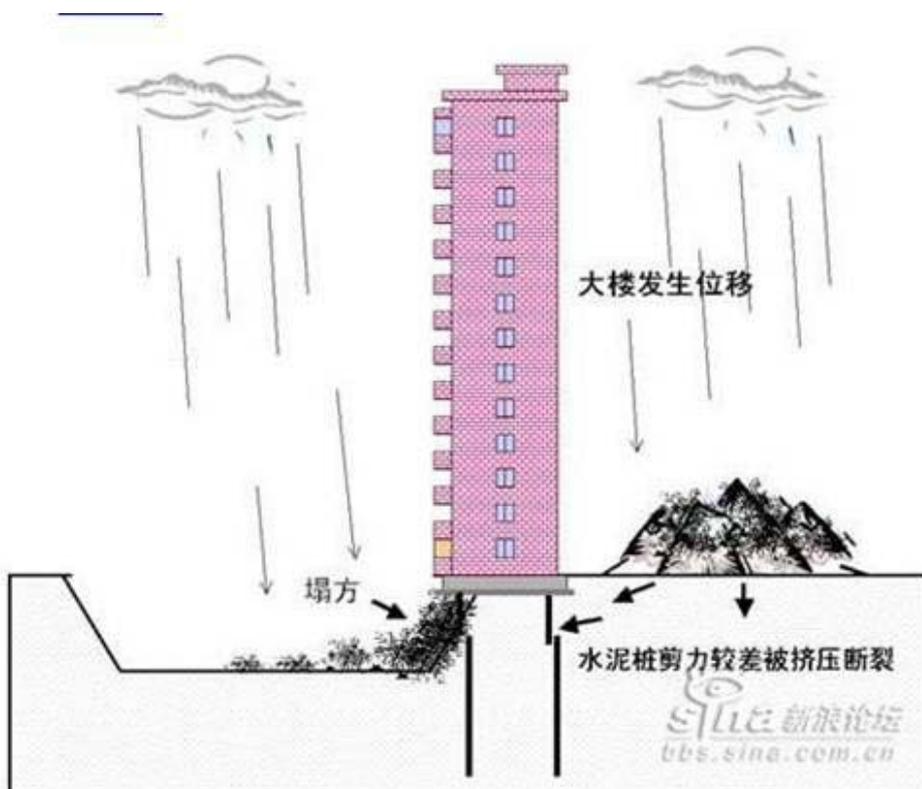
The building began to shift and the concrete pilings were snapped due to the uneven lateral pressures.

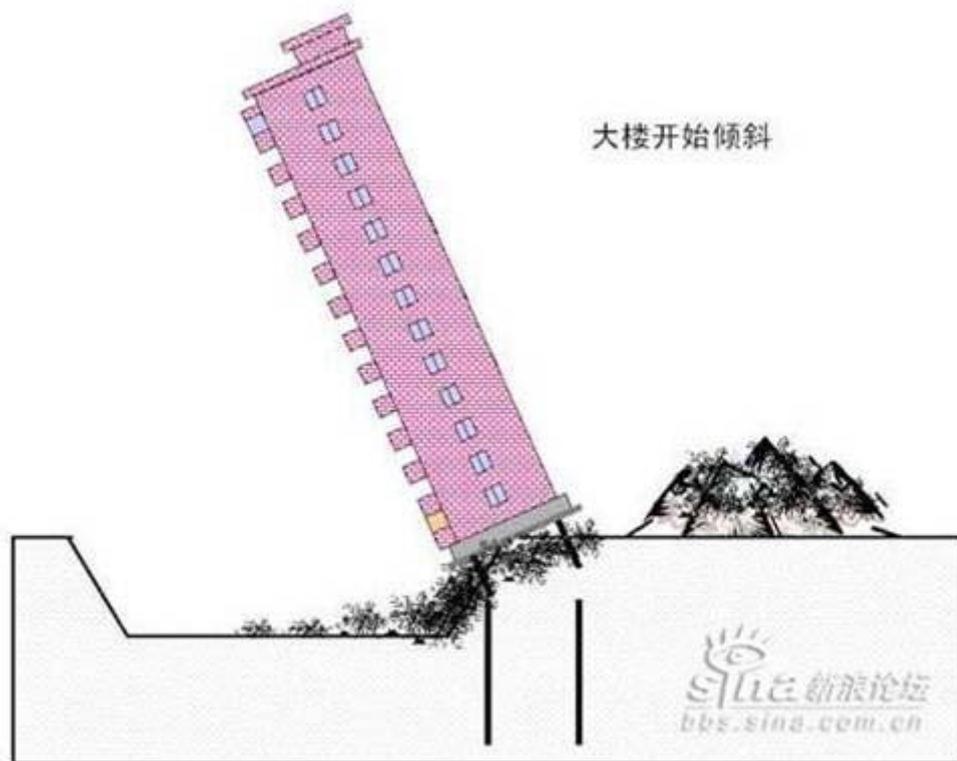
The building began to tilt.
