Fact behind Building Collapse in Shanghai

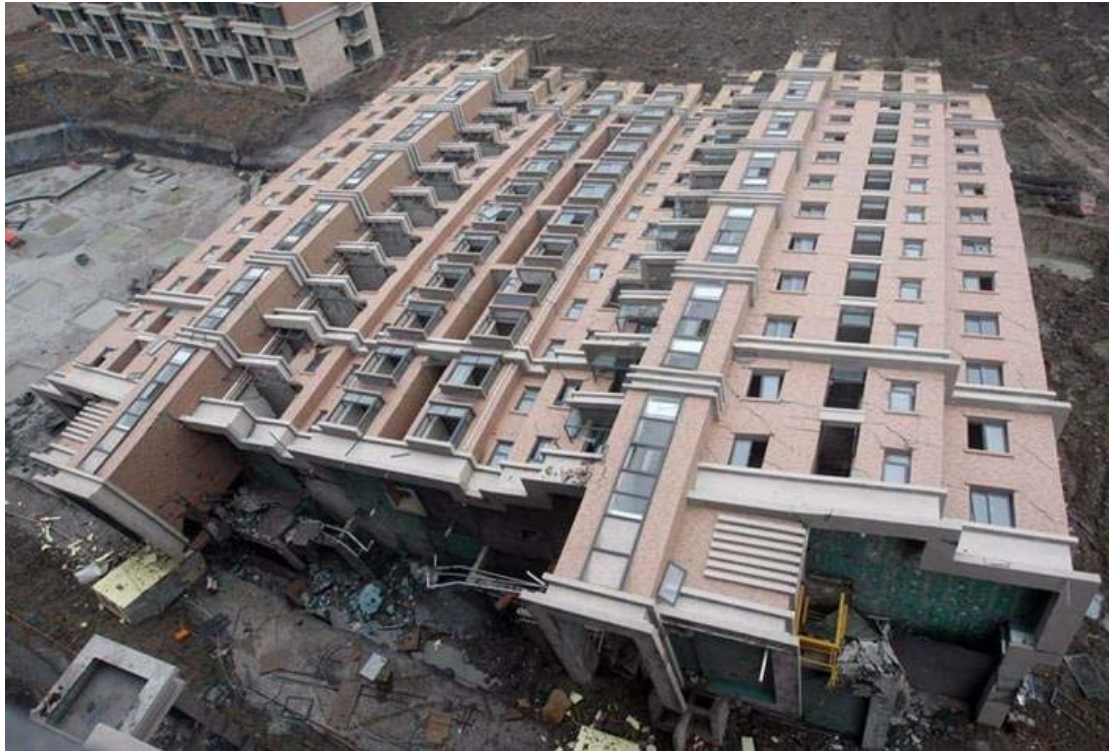
At around 5:30am on June 27, an unoccupied building still under construction at Lianhuan Road in the Minhang district of Shanghai city toppled over. One worker was killed. According to information, a 70 meter section of the flood prevention wall in nearby Dianpu River and that may have something to do with this building collapse. But the high-resolution photos are really amazing.
