## Fact behind Building Collapse in Shanghai

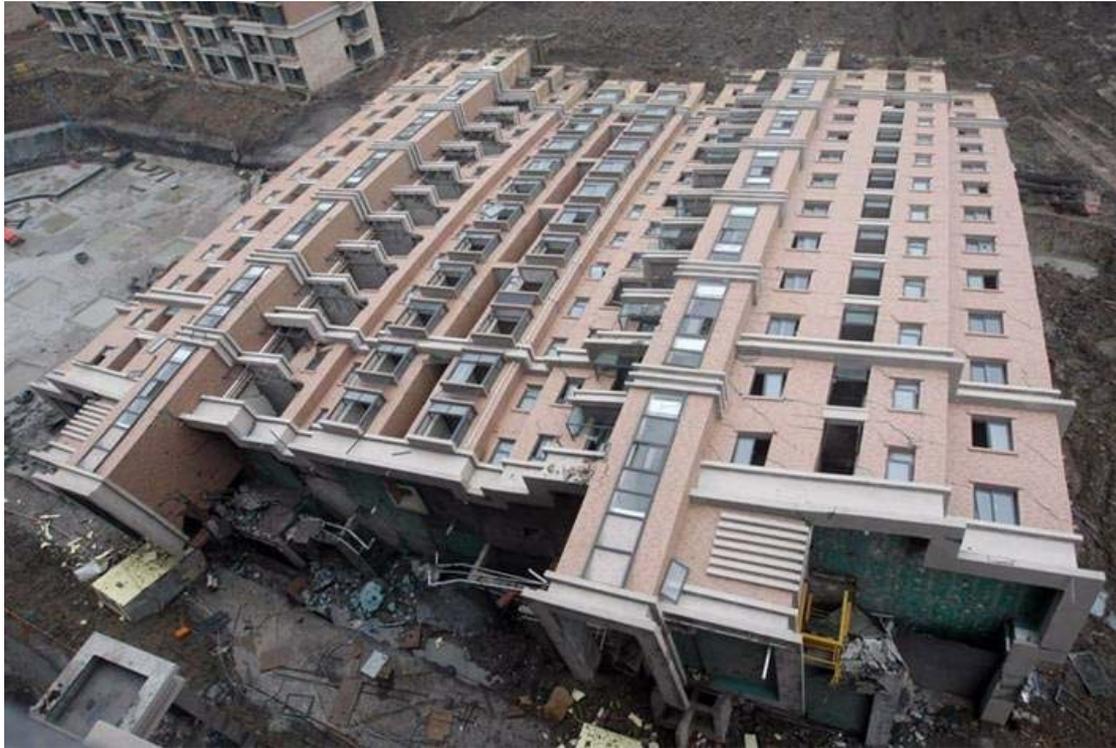
At around 5:30am on June 27, an unoccupied building still under construction at Lianhuan Road in the Minhang district of Shanghai city toppled over. One worker was killed. According to information, a 70 meter section of the flood prevention wall in nearby Dianpu River and that may have something to do with this building collapse. But the high-resolution photos are really amazing.

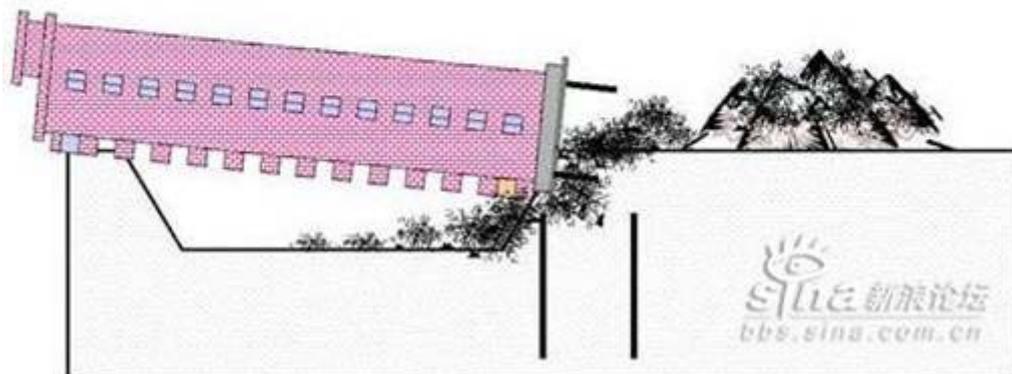
The building began to tilt.

And thus came the eighth wonder of the world.
